Lessons learned on design

Gary Johnson

J&P Technologies, 2045 Space Park Dr., Ste. 200, Houston, TX 77058, United States

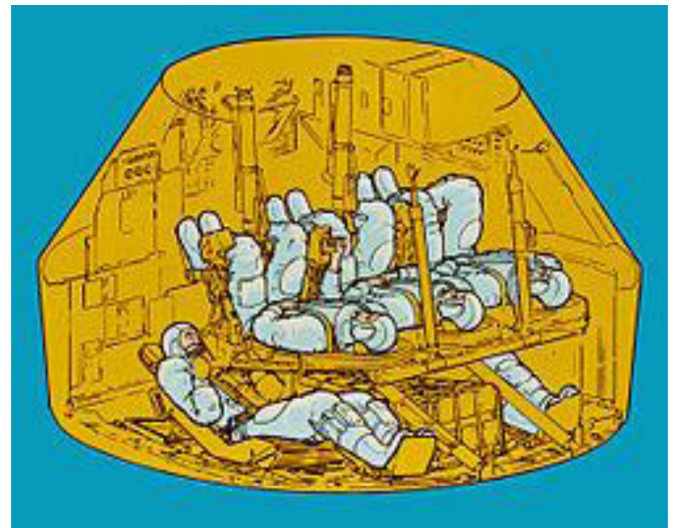
Fig. 1. Skylab 3 rescue mission crew location.

The CSM RCS Quad B forward-firing positive-yaw engine oxidizer valve had leaked, and the nitrogen tetroxide had frozen into the shape of the thruster exhaust cone. The crew also reported a “snow storm” on the right side (Quad B side) of the spacecraft at the same time. The Quad was isolated, and the rendezvous had to be completed with only three of the four SM Quads. The crew members had not trained for this, but were able to complete the docking to Skylab.

While rescue preparations were underway, Engineering concluded that the SM Quads did not share a common problem. The only condition that would match the timeline of events and leakage rates experienced on Quad D was an improperly torqued Dynatube connector. A contingency procedure was developed so that if another SM RCS Quad failed, the CM RCS could be used to de-orbit and for control during entry. The mission was allowed to continue, and the Skylab rescue capability was available if needed, reference 3.

The innermost and primary seal of a Dynatube connector is a mirror-finished, metal-to-metal seal. The second seal is a butyl O-ring. Tests showed that a finger-tight Dynatube connection would pass a preflight helium leak test. However, when the RCS system is pressurized prior to liftoff, the oxidizer penetrates the unmated primary metallic seal, and the O-rings alone seal the connection. Tests showed the butyl

O-ring degrades and can start leaking when exposed to nitrogen tetroxide at flight temperatures and pressures. The butyl O-ring seal was considered a redundant seal, but did not actually provide redundancy, creating a false sense of security.

Lesson: Redundant systems must use compatible materials to be effective. Flight-critical fluid connections should have controls in place to insure proper torquing of connections, and seals should be compatible with the fluid they are trying to seal.

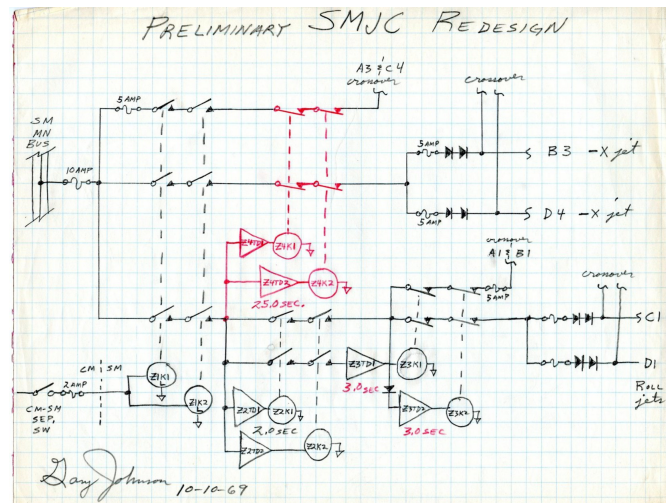
Fig. 2. Preliminary service module jettison controller redesign.

SM after separation. During lunar return, if the SM contacted the CM in the entry corridor the result would be catastrophic, so this triggered an anomaly investigation. Photographs obtained by aircraft showed the SM entering Earth's atmosphere and disintegrating in the vicinity of the CM entry corridor. Radar tracking confirmed what the photographs had shown. The radar tracking data for the previous Apollo 8 and 10 lunar return missions were similar to Apollo 11, with the SM entering in the same corridor as the CM.

The investigation analysis showed that under certain conditions, such as propellant slosh after separation, re-contact could occur. We were lucky, as analysis showed that if the –X RCS jets were turned off after 25 s it would prevent any chance of re-contact. That change was then made to the SMJCs for the later Apollo missions, see Fig. 2.

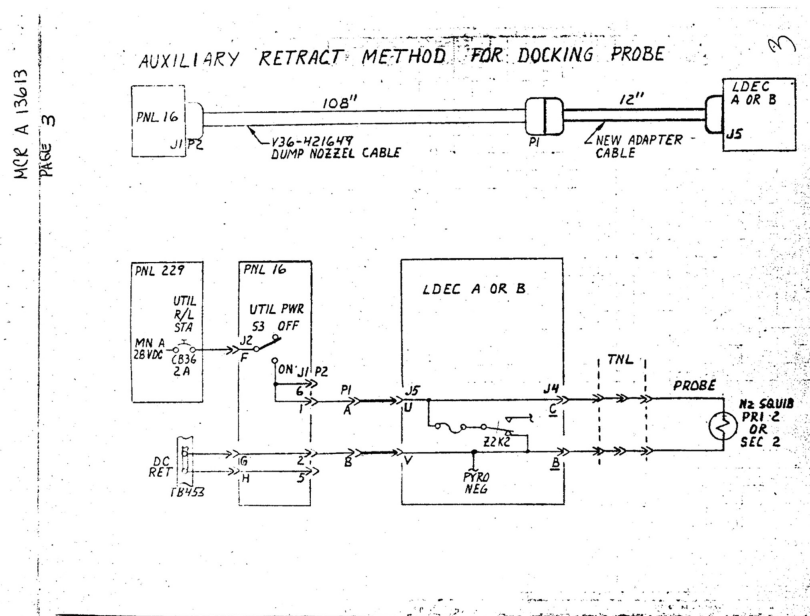
Fig. 3. Docking probe retract schematic.

After numerous attempts, the crew was unable to achieve soft dock. Movement after the previous soft dock may have damaged the capture latches. There was one more procedure in the checklist labeled "Final Docking Attempt." Following the checklist, the crew members donned the pressure suits, depressed the cabin, opened the tunnel hatch, removed the probe cover, and cut the wires. They also connected the emergency retract cable to the Utility Power Outlet and the other end of the cable to the Lunar Docking Events Controller connector J5, see Fig. 3. After firing the probe retract pyro using utility outlet power, the commander was able to make direct contact, triggering the 12 structural latches and achieving hard dock, see Attachment for location on the chart.

The procedure for achieving hard dock when capture had failed was developed during the Apollo 14 mission (see "Expect the unexpected, and never stop learning"). After Apollo 14 a special cable was developed and stowed in the CM and the right-hand equipment bay panel was modified to allow quick access to the J5 connector. The procedure did not require removing the probe retract cover to cut wires, for which the crew had to be suited and the cabin depressed. Later, without coordinating with Engineering, the Flight Operations personnel changed the crew checklist to require the cutting of the probe wires, reference 8.

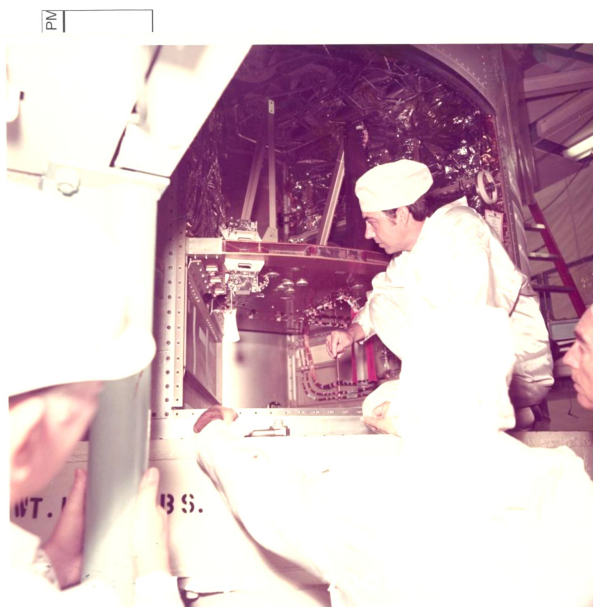
Fig. 4. Photo of Gary Johnson identification of faulty micro switch installation in ASTP service module.

without that boom coming back and colliding with the SM. On one of those missions the limit switches were not sensing properly, which was found to be an installation problem and was later corrected.

The quality assurance personnel could only verify that the installation matched the drawing, not that it matched the intended design. However, the designer could see if the drawing was wrong. That was the beauty of both NASA and contractor design personnel performing vehicle inspections. After the Apollo 1 fire, NASA required a "Management Walk-Around Inspection" of all spacecraft prior to shipment to KSC, and this continued in the Space Shuttle Program, reference 9.

Lesson: Design drawings should be updated following a design change. Engineering orders (attachments which show a change to a design) should not be overused. When an older design is being used, ensure that all of the subsequent modifications and changes have been

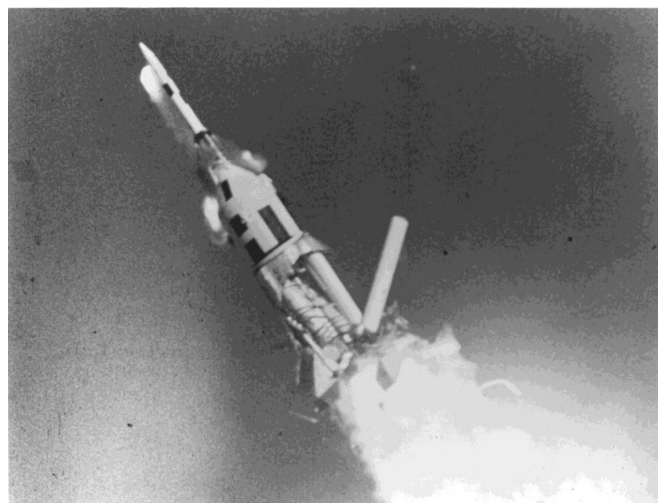
Fig. 5. Apollo BP-22 Little Joe II breakup.

Apollo Mission A-003 used a boilerplate spacecraft (BP-22) launched from Launch Complex 36 at White Sands Missile Range on May 19, 1965. The mission was a high-altitude test of the abort system, and the Little Joe II had six Algol solid rocket motors, making this the largest solid rocket motor launch at that time. Concern about the reliability of the abort signal from the launch vehicle led to using a loss of signal/open circuit rather than an electrical signal being sent. Three abort signals were to be sent in two-of-three voting in the spacecraft sequencer to initiate the abort. A radio frequency command was sent to the launch vehicle for the abort, which powered a relay opening the normally closed contacts, causing loss of signal to the spacecraft.

Shortly after liftoff one of the Little Joe fins failed hard-over, and the faster it went forward, the faster it spun around till centrifugal force caused the launch vehicle to structurally fail approximately 25 s after liftoff. The launch vehicle breakup, Fig. 5 caused the open circuit/loss of signal, and the spacecraft sequencer initiated an automatic abort of the BP-22 spacecraft, see Fig. 6. The spacecraft separated from the launch vehicle at a high roll rate. The drogue chute had steel cables as risers, which was beneficial, since the spacecraft upper deck was

Lesson: Engineering safety analysis should indicate what the abort signal to spacecraft should be if the launch vehicle structurally fails. Parachute risers should be designed for the worst case environment.

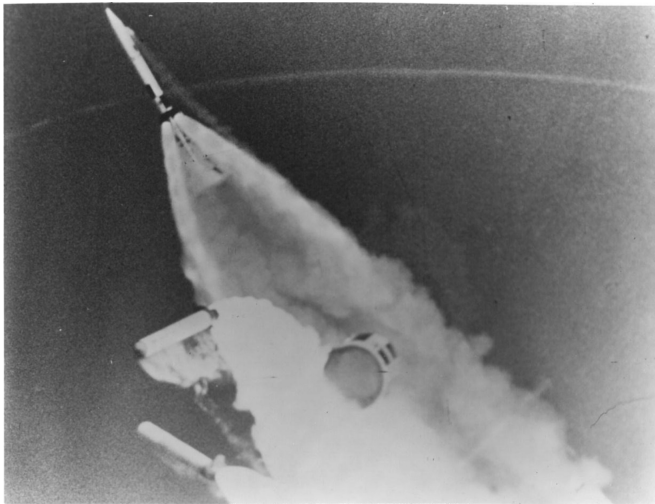
Fig. 6. Apollo BP-22 Abort.

damaged from the risers lashing around in the process of damping out the roll rate. The lower part of the main risers had a fine steel overwrap. Concern about spacecraft dynamics during parachute deployment causing damage to the parachute risers from upper deck sharp edges resulted in the changes to the parachute risers.

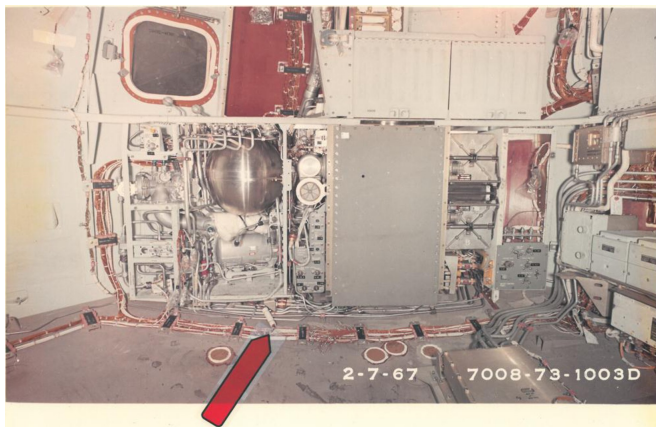
Fig. 7. Apollo Block 1 command module left hand lower equipment bay.

A significant part of the left-hand lower equipment bay was gone (metal, plumbing, wiring, etc.). This was where the fire started and was

the hottest, because the most oxygen was present. The most probable initiator was an electrical arc occurring near the floor in the lower forward section of the bay. Here, instrumentation power from a Teflon-insulated wire powered by Main Bus A and B was routed over metal plumbing and under a coolant control access panel, just below the left crew couch.

The wire harness, a twisted pair of wires, and power and power return had an extra Teflon overwrap for protection from the panel door and the metal plumbing. However, the last closeout photo of that area before the fire showed that the extra Teflon wrap had slipped down, and was not keeping the wire away from the plumbing. The wire harness had no extra protection from the panel door opening/closing or from ground test personnel or crew at the time of the test. The wire looked like it was touching the bottom of the panel door. Spacecraft movement was noted during the test, as the commander was reconnecting the communications cable, and the damage could have happened at this time. A simulation showed that he would have had to put his foot down, off the crew couch, to reconnect the cable, and would have placed his foot near this wire, see Fig. 7. Fig. 8 shows protective changes, hard portable flooring for ground crew and metal covers over wire harness, shown at far left and right. Middle is open in this photo.

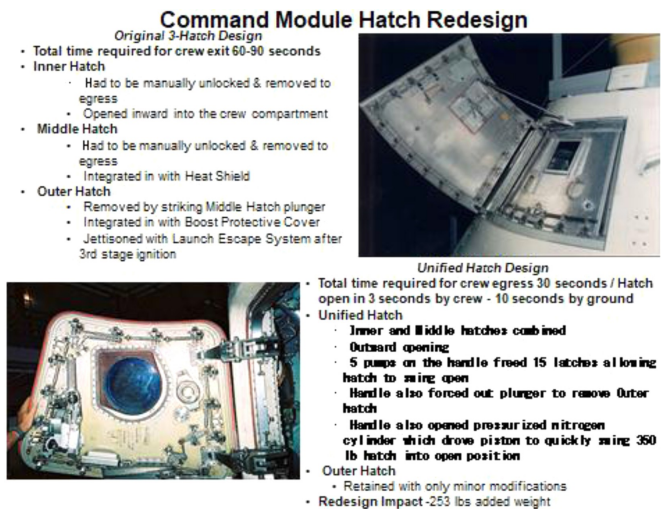
Fig. 9. Command module hatch redesign.

The crew cabin was pressurized to 16.7 psi with pure oxygen. The side hatch consisted of a two-piece, inward opening (pressure sealing) hatch. The fire increased the pressure, which made the hatch more difficult to open, so the crew was unable to open the hatch to escape. It took 90 s to remove the hatch from the outside and get them out.

Lesson: Hazard analysis should be performed on critical test configurations. All tests at 100% oxygen should be defined as hazardous. Emergency training should be required for all test support personnel, and test areas should be equipped with appropriate emergency, fire-fighting, or rescue equipment. The selection and placement of materials inside the spacecraft must be compatible with the spacecraft environment. The crew ingress/egress hatch should be a single, outward-opening hatch requiring only 5 s to open, see Fig. 9.
