Lessons learned on design

Gary Johnson

J&P Technologies, 2045 Space Park Dr., Ste. 200, Houston, TX 77058, United States

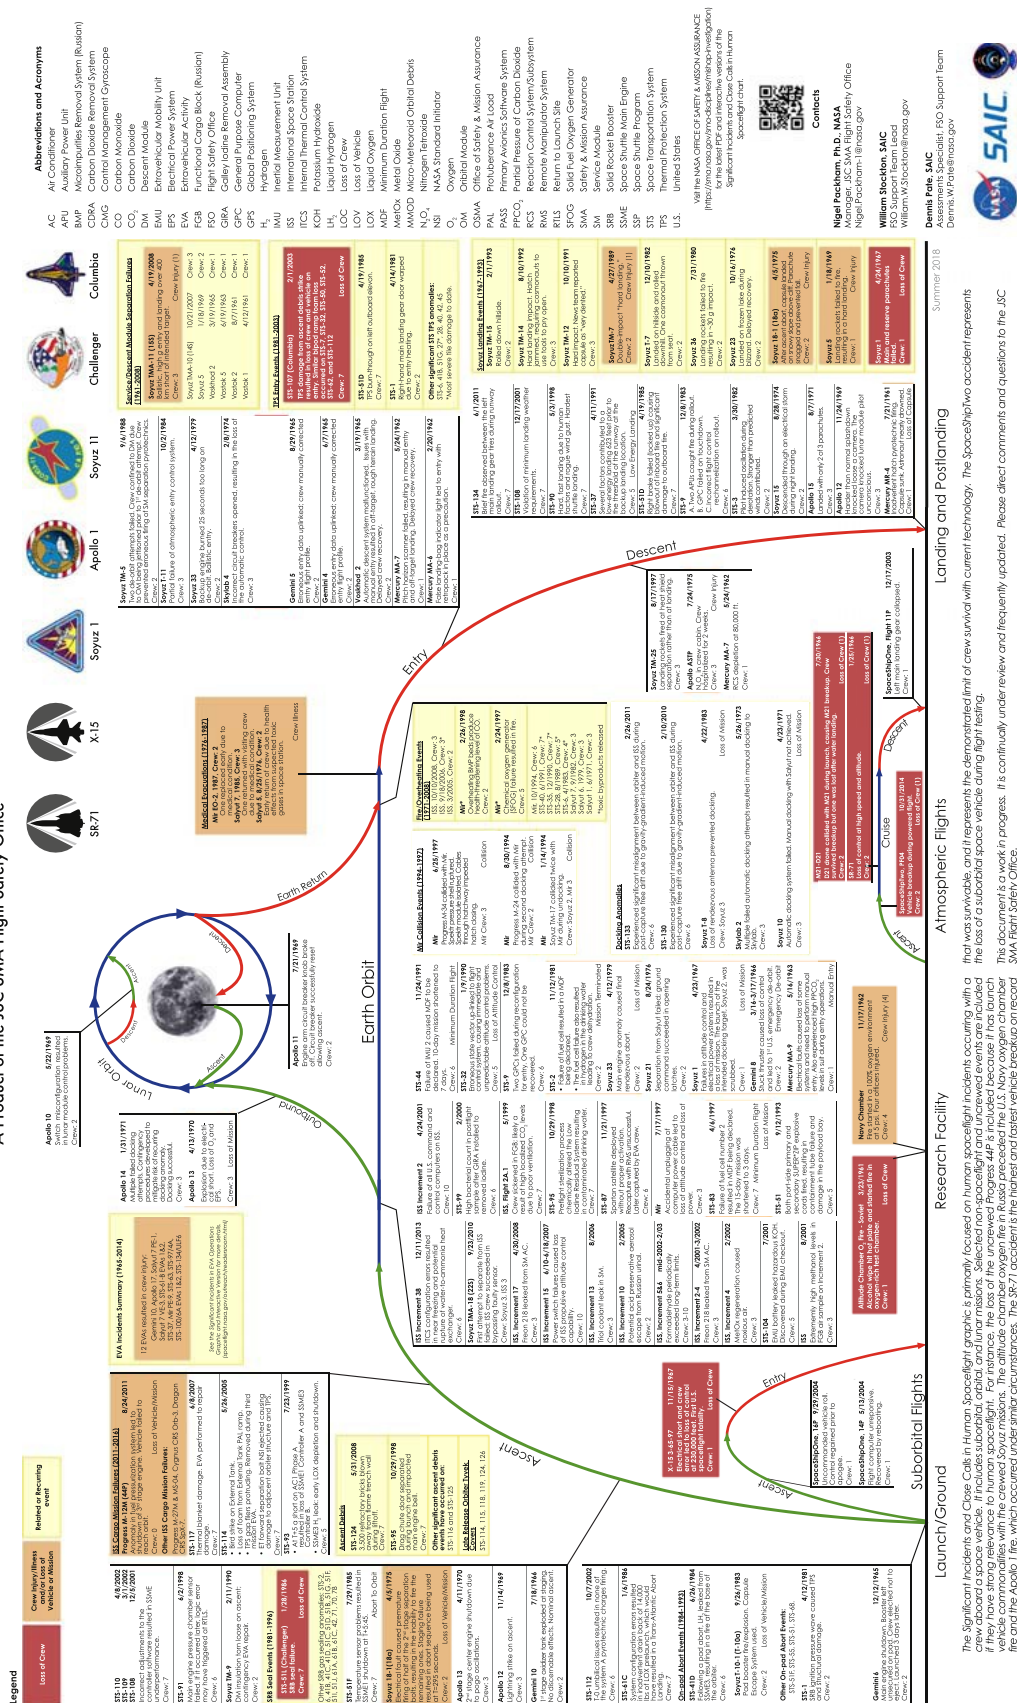
The Significant Incidents and Close Calls in Human Spaceflight graphic is primarily focused on human spaceflight incidents occurring with a crew aboard a space vehicle. It includes suborbital, orbital, and lunar missions. Selected non-spaceflight and uncrewed events are included if they have strong relevance to human spaceflight. For instance, the loss of the uncrewed Progress **MP** is included because it has launch vehicle commonalities with the crewed Soyuz missions. The attitude chamber oxygen fire in Russia preceded the U.S. Navy oxygen chamber fire on the Aqualia. The fire, which occurred under similar circumstances, the SR-71 accident is the highest and fastest in-flight breakup on record.
